Combined Playground

## Annual Inspection

### Broadwas Berryfields

10 October 2025

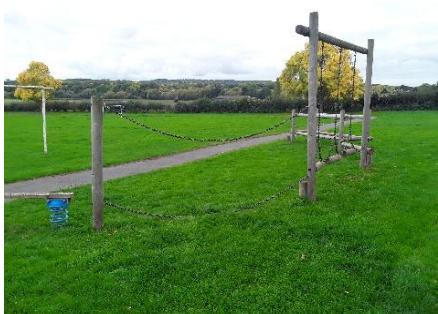
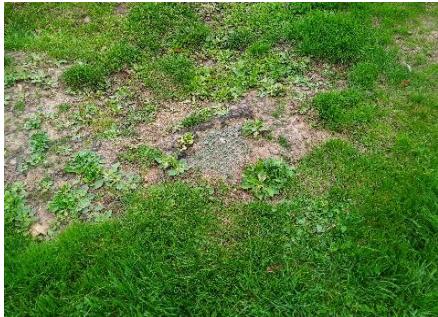
## Site General

- 1 There is a redundant base present, the equipment has been removed and the reinstatement subsided. The remaining grass mats are damaged creating Trip Hazard

- 1 Provide a uniform surface and remove the Trip Hazard.

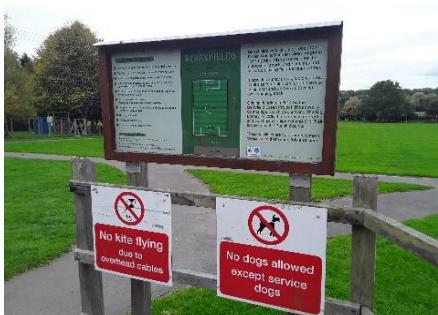
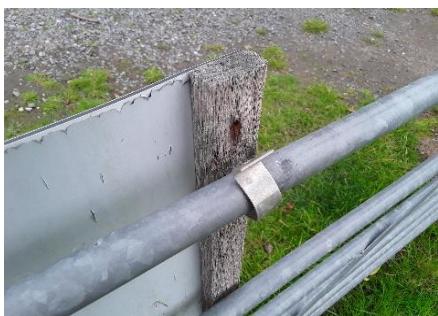
## Signs

- 1 BS EN 1176 Part 7 recommends that signage with information including, but not limited to, the site address, contact information for maintenance issues and emergency contact details are provided at each entrance to the playground facility
- 2 Signage should be provided for the outdoor fitness equipment in accordance with the requirements of BS EN 16630, key requirements of the sign include, but are not limited to, intended users, medical safety and emergency contact details
- 3 There are fixings missing from the gate signage

- 1 Provide suitable signage in accordance with the recommendations set out in BS EN 1176

- 2 Provide suitable signage in accordance with the recommendations set out in BS EN 16630

- 3 Replace the missing fixings

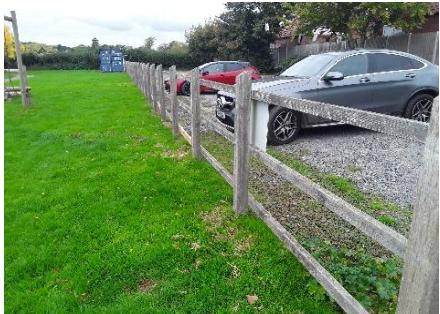
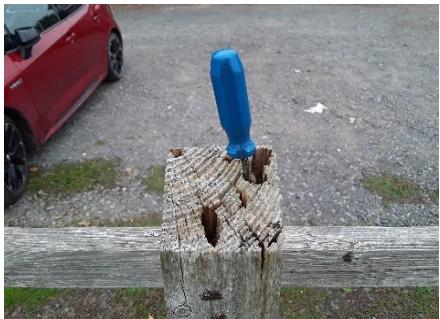
## Post and Rail Fence

- 1 There are parts of the timber posts that have rotted

- 1 Replace all affected timbers

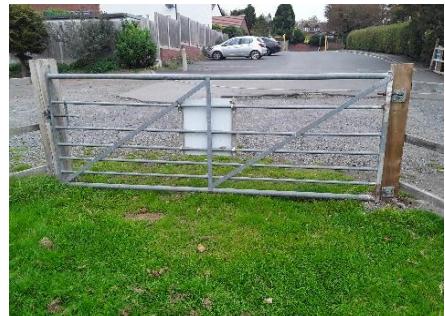
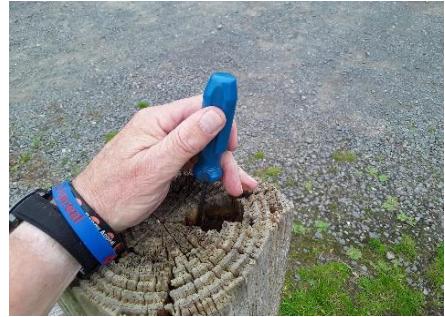
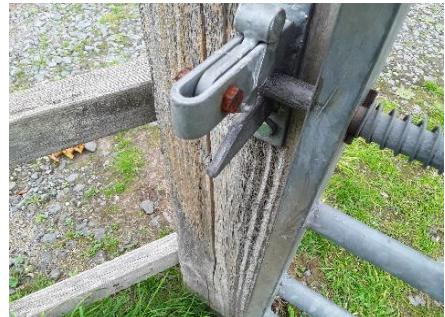
## Maintenance Gate

- 1 There are openings that are less than 12mm that could trap or crush users' fingers
- 2 There are parts of the timber gate posts that have rotted
- 3 There is no padlock on the maintenance gate

- 1 Where possible a 12mm gap should be provided on both sides or between the gate leaves

- 2 Replace all affected timbers

- 3 Provide a padlock to secure the gate

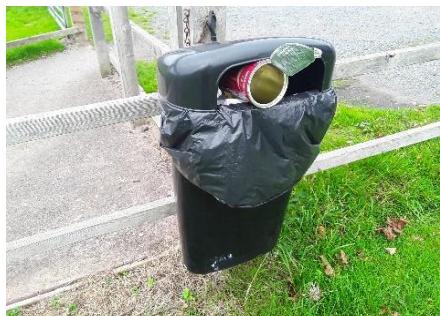
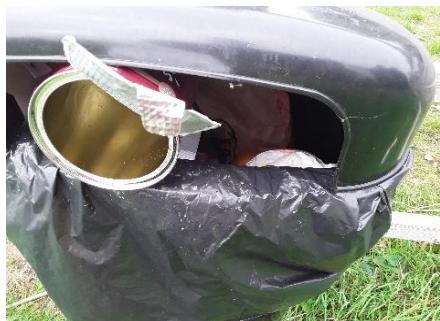
## Litter Bin

- 1 The litter bin is full

- 1 Empty and review the collection routine

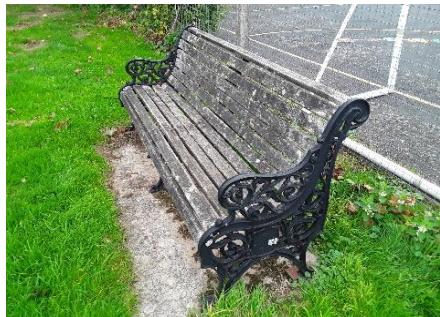
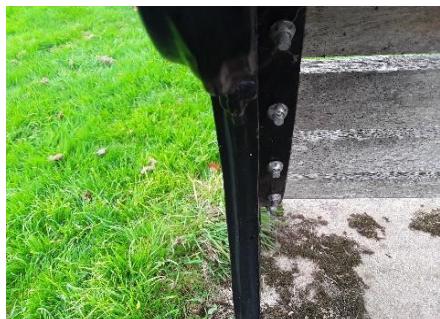
## Bench

- 1 There are projecting bolt thread(s) present

- 1 Remove the excess thread length and deburr or provide a cap

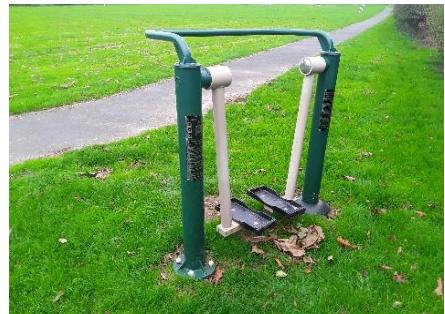
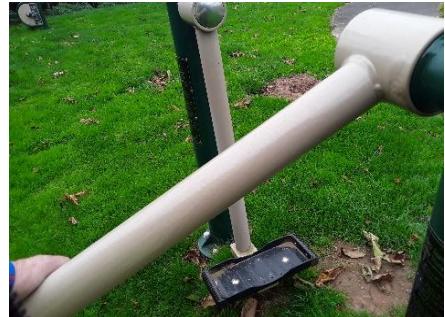
**Air Walker**

- 1 The swinging movement of the arm exceeds the maximum 55 degrees from the vertical as required by BS EN 16630

- 1 Monitor - No remedial work recommended

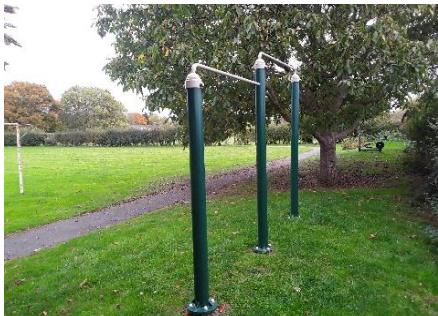
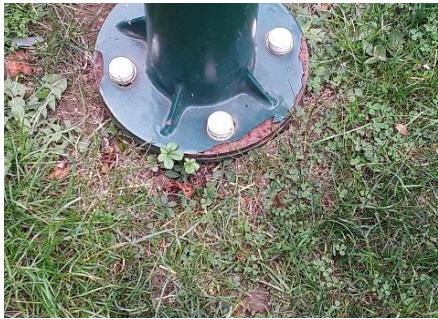
## Pull Up Station

- 1 There are bolt caps missing
- 2 The paintwork on this item has been damaged or worn exposing the metal underneath which is rusting

- 1 Replace the missing bolt caps

- 2 Treat any rusting components and repaint

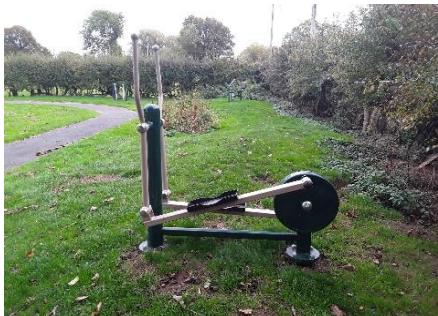
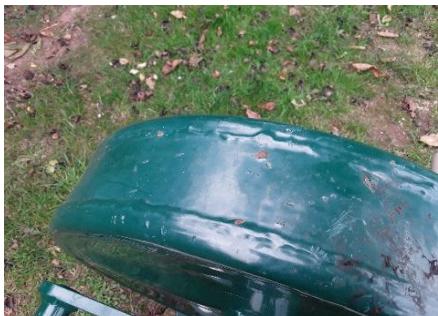
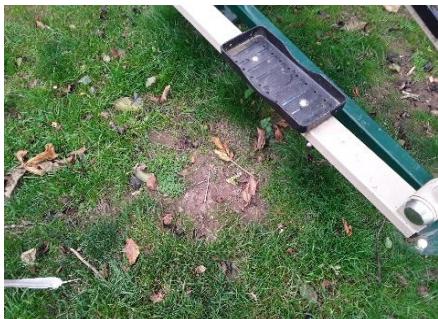
**Cross Trainer**

- 1 There are variable gaps of between 8mm and 60mm creating a potential crush / shear point between components in contravention of the requirements of BS EN 16630
- 2 The paintwork on this item has been damaged or worn exposing the metal underneath which is rusting
- 3 The surface has eroded and may be slippery in wet conditions

- 1 Monitor - No remedial work recommended
- 2 Treat any rusting components and repaint

- 3 Reinstate eroded area

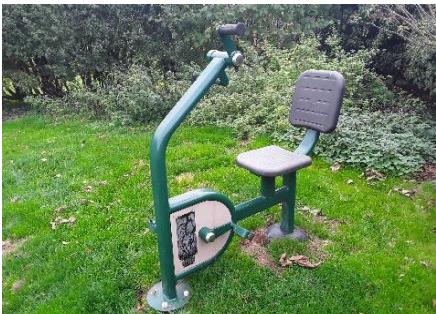
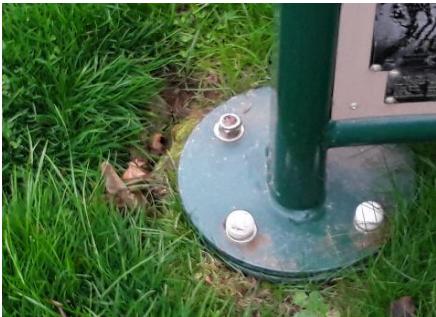
**Hand Bike**

- 1 There are variable gaps of between 8mm and 60mm creating a potential crush / shear point between components in contravention of the requirements of BS EN 16630
- 2 There are bolt caps missing

- 1 Monitor - No remedial work recommended

- 2 Replace the missing bolt caps

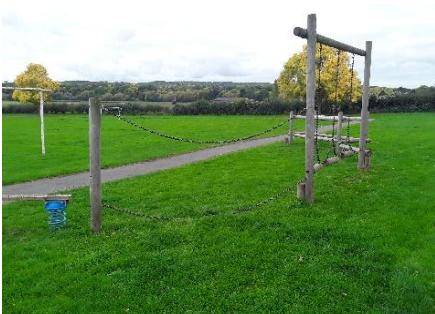
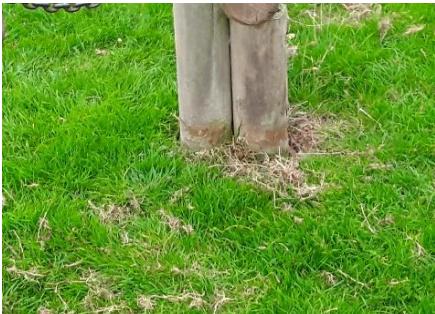
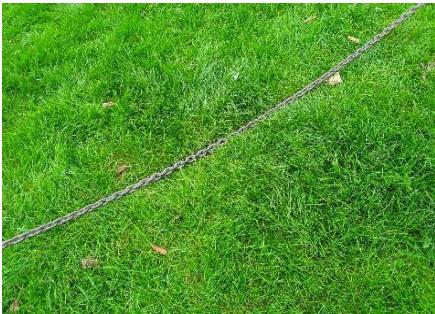
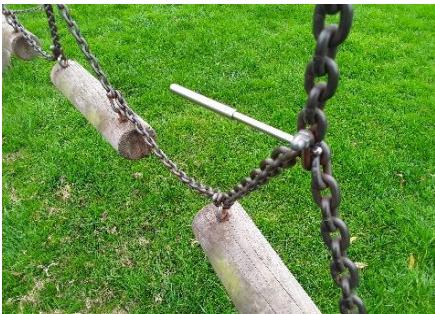
## Balance Trail

- 1 This item of equipment relies on a single post, or a line of posts, for stability and extra care needs to be taken with equipment of this nature to avoid the potential for catastrophic failure
- 2 There is strimmer damage apparent on the posts and this can accelerate the rotting process
- 3 The balance chain is snagging the surrounding surface
- 4 The connecting links are in excess of 8.6mm and less than 12mm and fail the requirements of BS EN 1176 Part 1

- 1 Ensure that regular detailed inspections are undertaken to assess for rot, corrosion and general stability

- 2 Monitor for further deterioration (rot) and replace if required

- 3 Lift / shorten the chain

- 4 Replace with compliant links at the next maintenance cycle

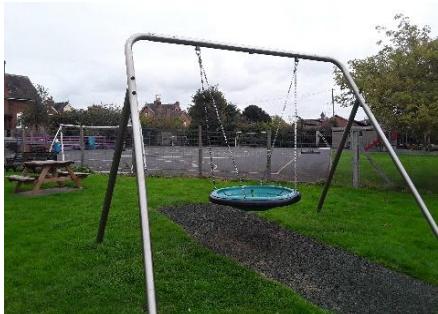
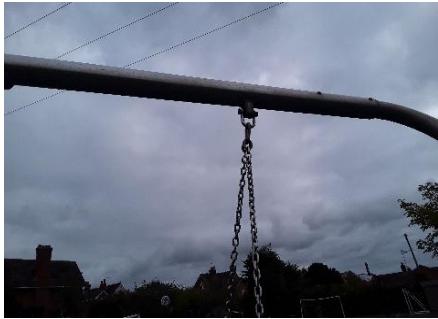
**Basket Swing**

- 1 To comply with BS EN 1176 Part 2 swings of this design should have a secondary safety mechanism fitted to prevent collapse of the seat in the event of a joint failure , however the manufacturer has confirmed that the joint was independently tested by the BSi

- 1 Monitor use and check the joint and fixing security regularly

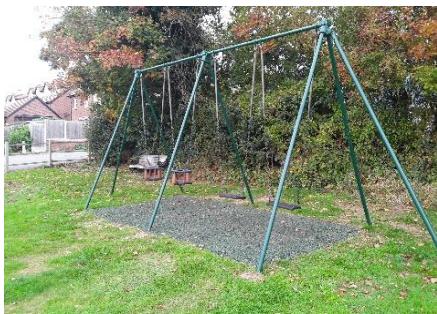
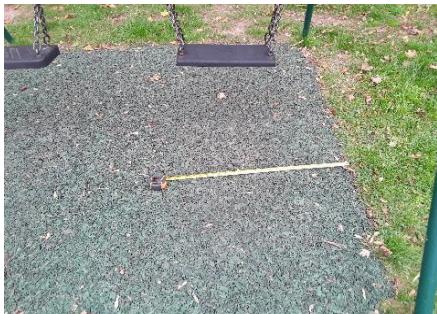
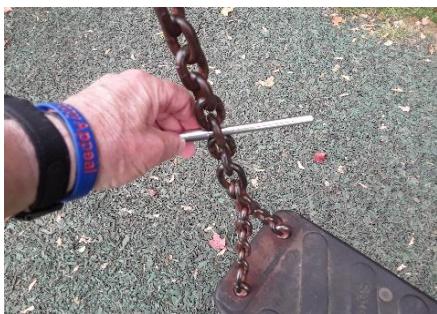
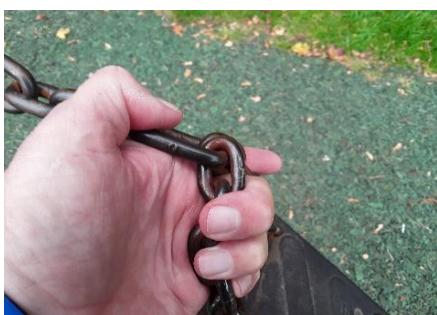
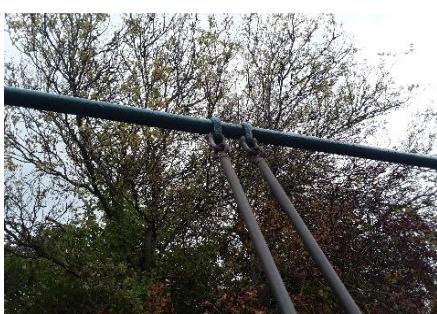
## Two Bay Mixed Swing

- 1 The seat is too close to the frame as defined in BS EN 1176 Part 2
- 2 The chain openings are in excess of the 8.6mm as recommended by BS EN 1176
- 3 There is notable evidence of chain wear
- 4 The bushes are showing signs of wear

- 1 Monitor - No remedial work recommended

- 2 Replace with compliant links at the next maintenance cycle

- 3 Monitor for further deterioration and replace when 40% worn

- 4 Monitor for further deterioration and replace as required

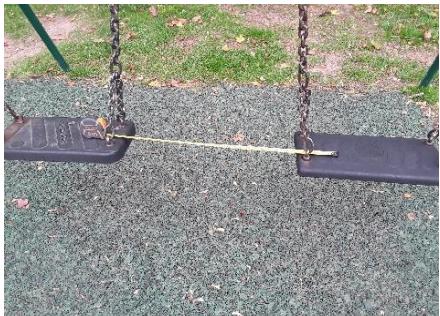
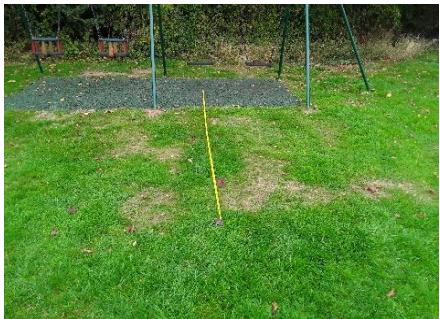
## Two Bay Mixed Swing continued

- 5 The seats are too close to each other as defined in BS EN 1176 Part 2
- 6 The surfacing dimensions are short and do not meet with the requirements of the current applicable standard. The item of equipment has a fall height exceeding 1.50 metres and grass has been provided as a safety surface in contravention of the applicable standard; NOTE - Well maintained grass is only suitable for fall heights of upto 1.50m and the actual fall height is 1650mm

- 5 Monitor - No remedial work recommended

- 6 Monitor - no remedial action recommended

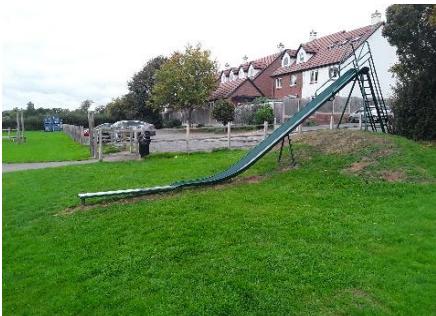
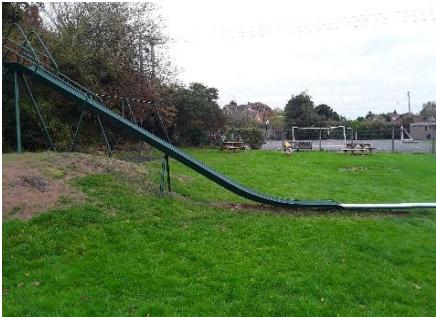
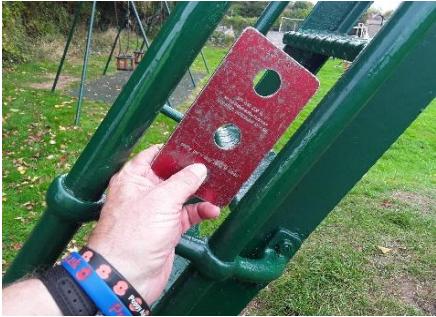
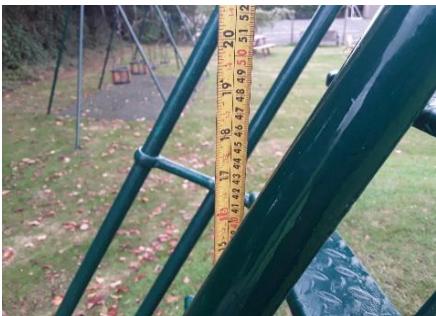
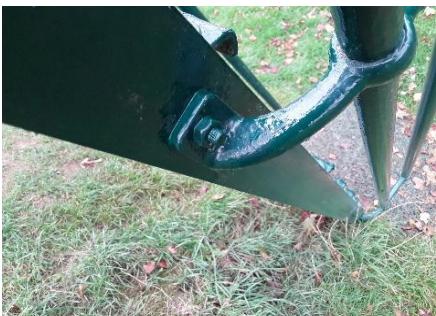
## Free Standing Slide

- 1 This item of equipment has a fall height in excess of 2.5m and grass mats have been installed as an impact absorbing surface; these mats rely heavily on the underlying surface to achieve their critical fall height properties.
- 2 The item fails to meet the requirements of BS EN 1176 Part 1 4.2.7.2 for head and neck entrapment in the handrail openings
- 3 The height of the handrail is too low and fails to meet the requirements of BS EN 1176 Part 1
- 4 There are projecting bolt thread(s) present

- 1 Ensure surfacing certification is sought and consider HIC testing to ensure the surfacing is performing adequately

- 2 Monitor - No remedial work recommended

- 3 Monitor - No remedial work recommended

- 4 Remove the excess thread length and deburr or provide a cap

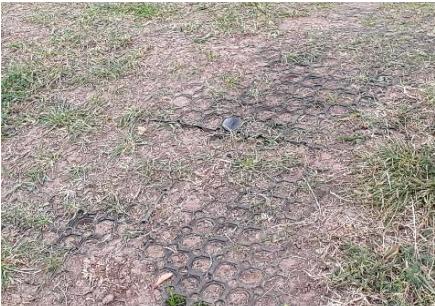
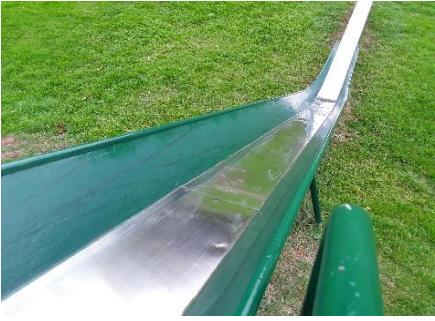
## Free Standing Slide continued

- 5 The grass mats are silted up and the soil is compacted; this may have an adverse effect on the impact absorbing properties of the surface
- 6 Fixing Pins have been installed in the impact areas of the grass mats and the free fall height is in excess of 600mm
- 7 There are dents in the sliding surface

- 5 Consider HIC testing impact absorbing properties to ensure the correct surface qualities are maintained for the equipment and replace the surfacing if required

- 6 Remove the pins from impact areas

- 7 Monitor and repair / replace if required

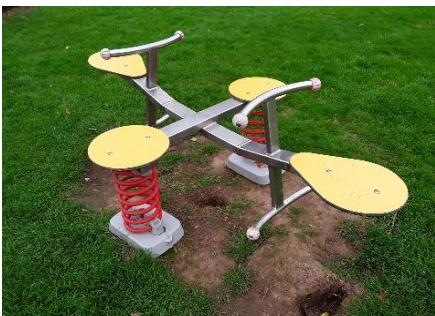
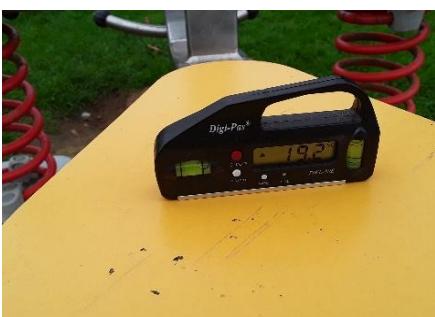
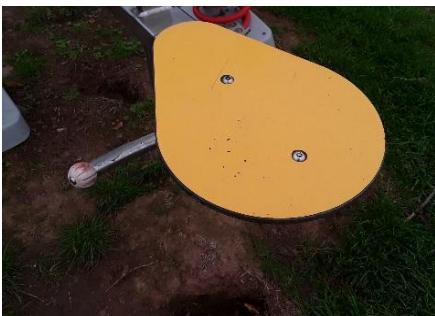
## Spring See Saw

- 1 There are holes / damage to the surface
- 2 The surface has eroded and may be slippery in wet conditions
- 3 The seat is not level when at rest
- 4 The seat has minor damage or wear

- 1 Reinstate to provide a uniform surface

- 2 Reinstate eroded area

- 3 Adjust the seat

- 4 Monitor for any further deterioration and replace as required
